**Subject: Limited Structural Evaluation Report (Handrails and Guardrails)**

**Project:** [REDACTED]

*True Building Engineers Inc (TBE) Job No. 5041*

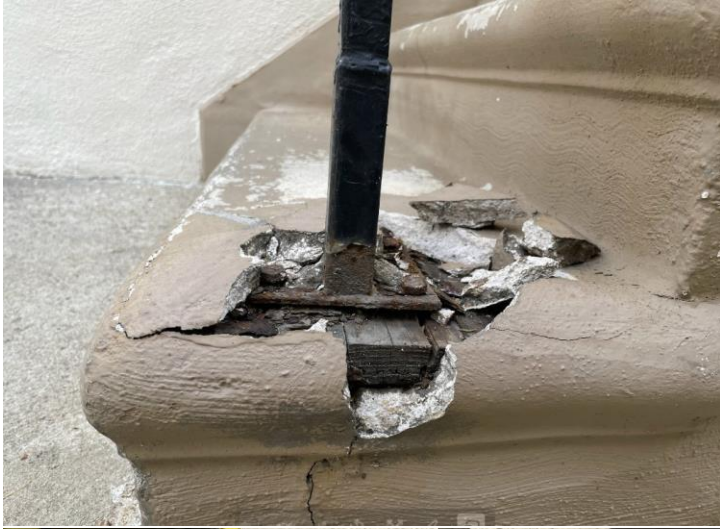
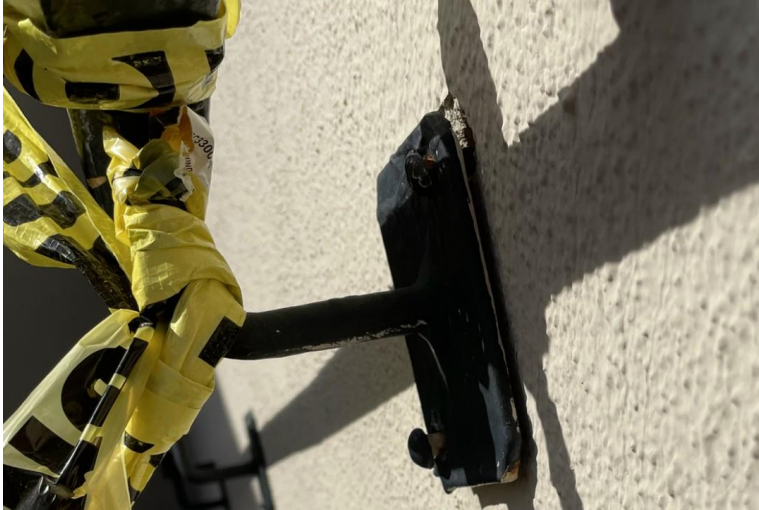
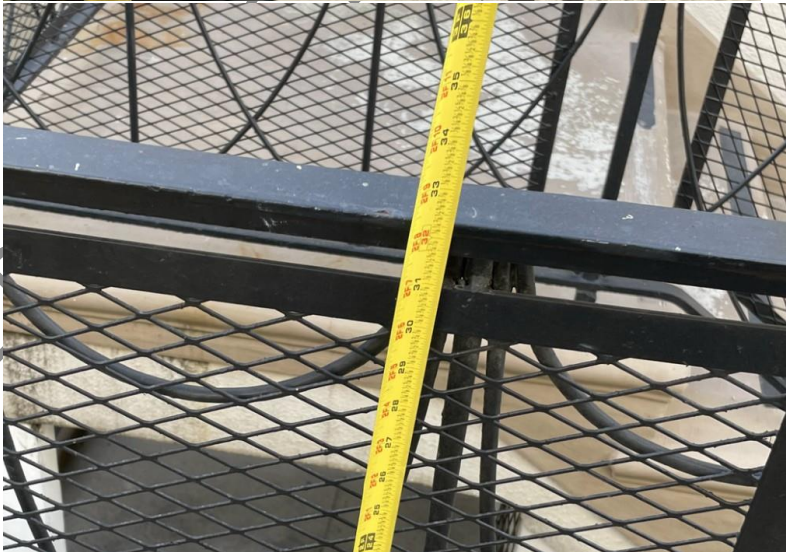
Enclosure – Photos

Several guardrail assemblies tested by pushing the top railing notably deflected out of plane. From a visual assessment of the exposed base plate anchor, it appears the large

deflections of the guardrail assemblies are due to inadequate anchorage design into existing wood framing and or damage of existing wood framing (potentially due to water) which is not allowing the lag screws to develop their full capacity. Another concern for the guardrail assemblies is the height relative to the finished floor. Per 2019 CRC Sec. R312.1.2 and CAC 1015.3 all guardrails are required to be 42 inches in height. It was observed the average guardrail height was approximately 36 ¾ inches and at the intermediate landings between the first and second floor only 32 inches in height. The handrails were observed to be without structural concern, however there was one handrail assembly observed that had one disengaged lag screws at the anchorage.

We recommend removing existing guardrails and replacing them with a new guardrail system that is designed by design professionals to meet current code requirements to be approved by the local jurisdiction. In addition, it would be prudent to remove existing finish floor materials to inspect wood for signs of damage. Damaged wood framing members shall be replaced to properly engage the guardrails anchorage system that compromise of lag screws penetrating the wood member. Handrails observed to be without concern of replacement, but we recommend that any loose anchor screw be properly re-anchored into the stud framing system.
